Environmental Effects of Dredging Technical Notes

EQUIPMENT MOBILITY IN CONFINED DREDGED MATERIAL DISPOSAL AREAS; FIELD EVALUATIONS

PURPOSE: This technical note describes recently completed equipment evaluations and presents data on mobility of this equipment in confined dredged material containment areas. The equipment evaluation included newly developed four- and six-wheeled low-ground-pressure vehicles. This equipment is typically used to tow a rotary ditching device to create surface trenches to enhance drainage and dewatering of confined dredged material disposal sites.

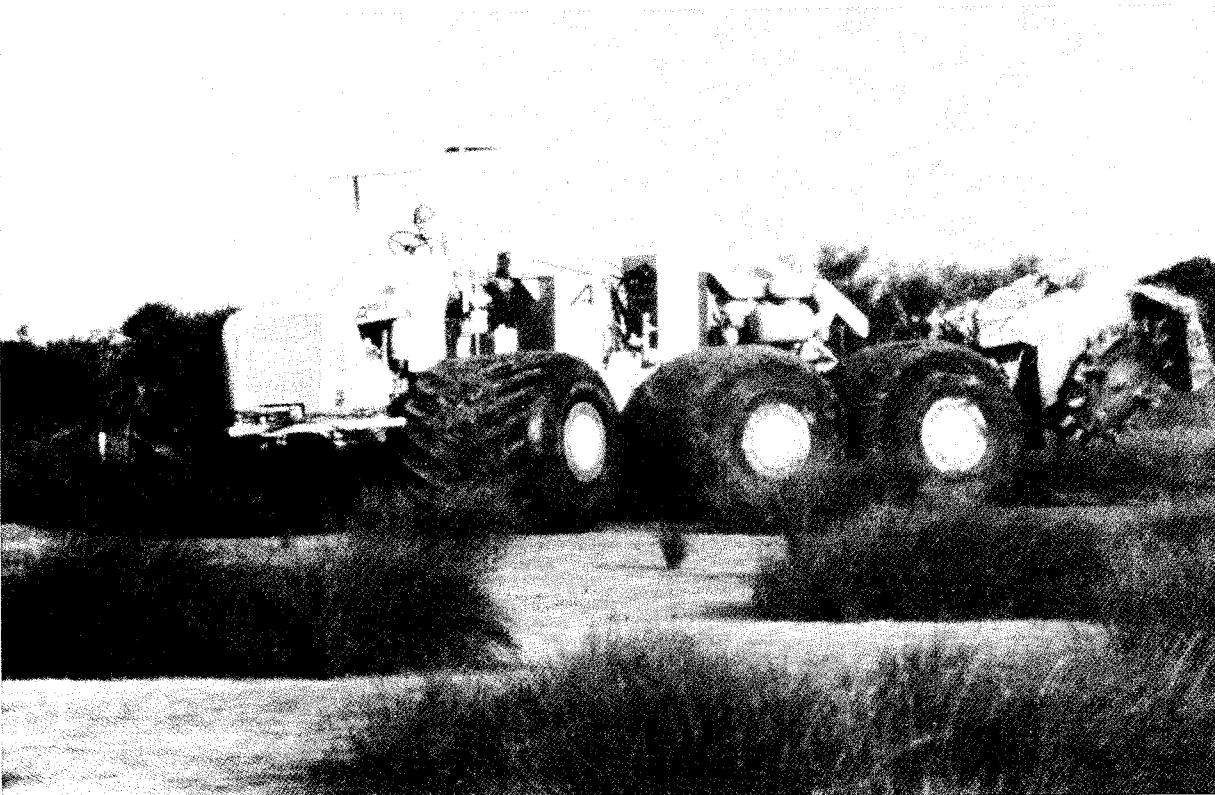
Figure 3. Rubber-tired ARDCO vehicle with Dondi ditcher raised between trenching operations in Triple Barrel disposal site

The equipment tested at Triple Barrel was an ARDCO "K" 6x6 rubber-tired vehicle which pulled a Dondi 95 ditcher (shown operating in Figure 3). The equipment is owned and operated by ARDCO of Houston, TX. The ARDCO has 113 hp and weighs 22,100 lb; it has a vehicle ground contact pressure of 1/64 psi. A tracked marsh buggy was kept on standby at the disposal site to pull the ARDCO

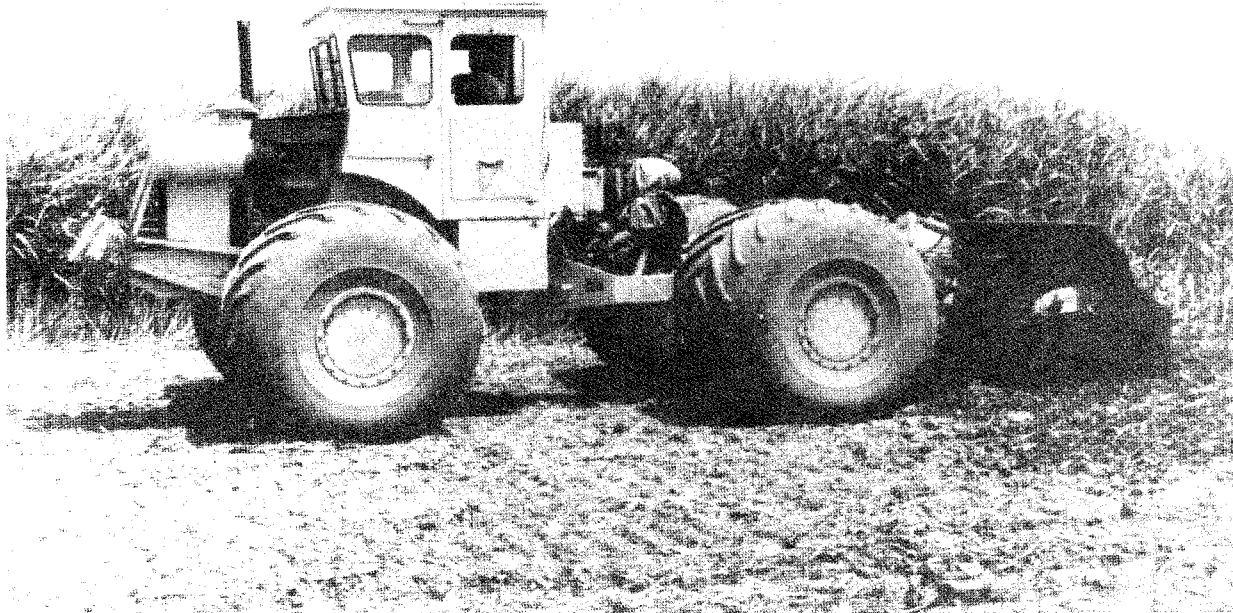
Figure 7. GEMCO vehicle with Dondi ditcher being lowered into position for trenching

The Artificial Island disposal area was the location of field equipment evaluations on June 15-17, 1987. The disposal site, located approximately 60 miles southwest of Philadelphia, is compartmentalized into three separate cells by interior dikes. Figure 6 is a map of the Artificial Island site. Each cell has one weir for water drainage. The dredged material in Artificial Island is predominantly sandy clay. No specific information was available on the thickness of the dredged material deposit in this site. All three cells were covered with a thick growth of *Phragmites* which had to be removed by bulldozing before trenching could begin to prevent entanglement of the vegetation in the rotary ditching device (Figure 7).
